**Chubby Hubby
Home Inspection, P L L C**

Inspectors: Dale Sherman TREC 21563 & Maryann Sherman TREC 24716

PROPERTY INSPECTION REPORT FORM

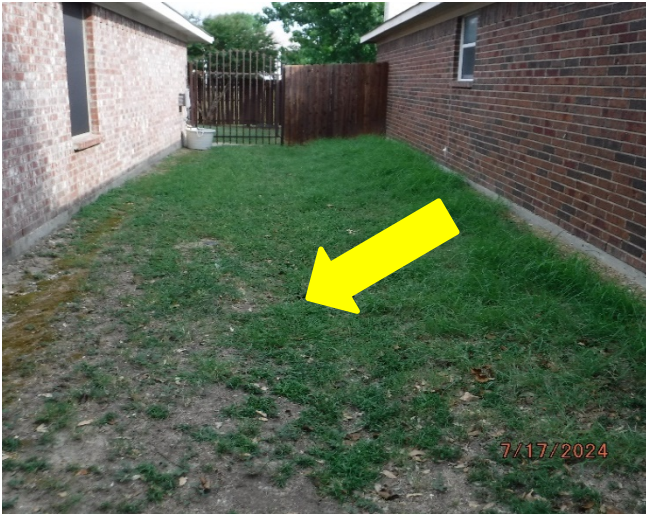
Figure 1

- The lot was lower relative to the neighbors on the right. If water intrusion and ponding occur. The inspector recommends a licensed landscaper evaluate and correct the issues which could involve re-grading or adding a drainage system. **(Figure 1)**

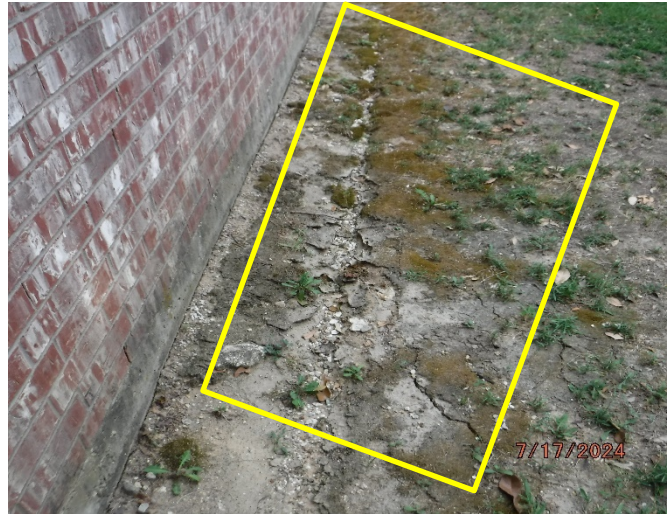
Figure 2

- There were low areas and areas of bare soil where ponding may occur. Recommend adding additional soil. If ponding continues, the inspector recommends a licensed landscaper evaluate and correct the issues which could involve regrading or adding a drainage system. **(Figure 2)**

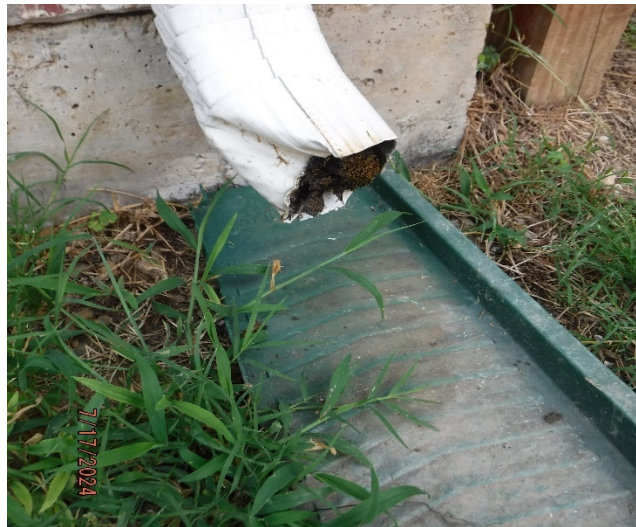
Figure 3

- There was a damaged gutter downspout turn-out on the back of the home. Recommend repair. **(Figure 3)**
- Note: There were down spouts that do not extend at least 3 feet away from the foundation. This may cause ponding at the foundation; the foundation needs equal watering at all points. Recommend extending the down spout 3 feet.

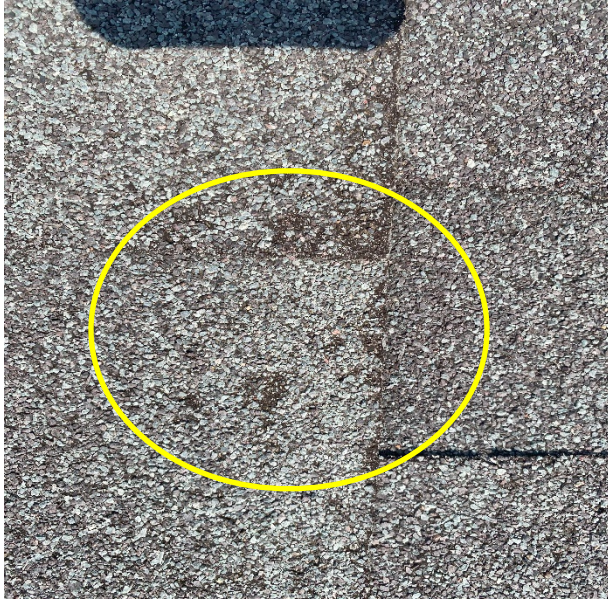
Figure 4

- The composition roofing material had signs of aggregate loss at the shingle and/or shingle edges. Recommend an evaluation by a roofing contractor. **(Figure 4)**

The inspector recommends that all the roof covering materials deficiencies listed above be evaluated and repaired by a Roofing Contractor. The Roofing Contractor may find additional defects besides those listed above.

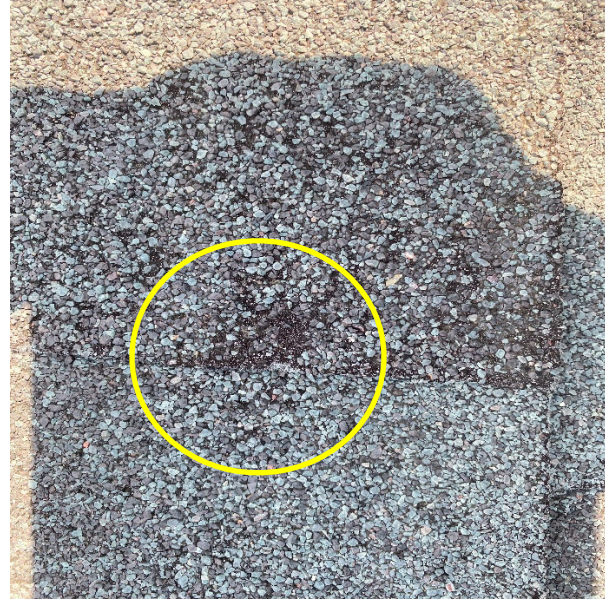
Figure 5

- There were signs of impact damage on shingles in areas around the home. Recommend an evaluation by a roofing contractor. **(Figure 5)**
- Note: The condenser did not have a rain diverter on the roof over the unit. This may cause premature failure of the condenser. Recommend adding a diverter.

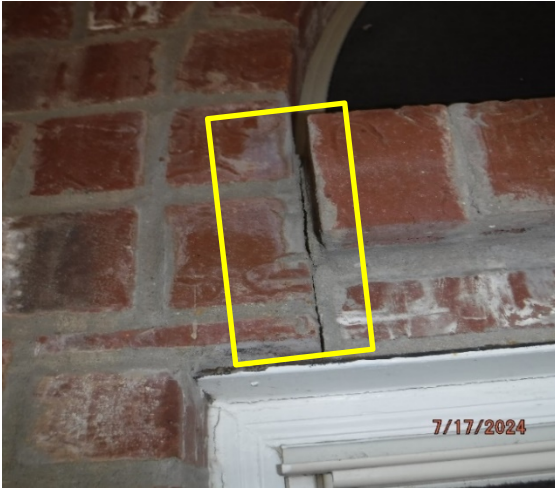
Figure 6

- There were areas of wall brick-and-mortar joint separation above the front entry door. Recommend an evaluation and repair by a mason. **(Figure 6)**
- There were expansion joints that have cracked and/or missing caulk, recommend adding elastomeric caulk to prevent water intrusion and termite infestation. **(Figure 7)**
- There are missing weepholes over the garage door. Recommend adding weepholes for drainage. **(Figure 8)**
- Note: There were exterior faucets that should be sealed at the wall connection points to prevent water intrusion.
- Note: There were exterior lights that should be sealed at the wall connection points to prevent water intrusion with elastomeric caulk.

The inspector recommends that all the external wall deficiencies listed above be evaluated and repaired by a General Contractor. The General Contractor may find additional defects besides those listed above.

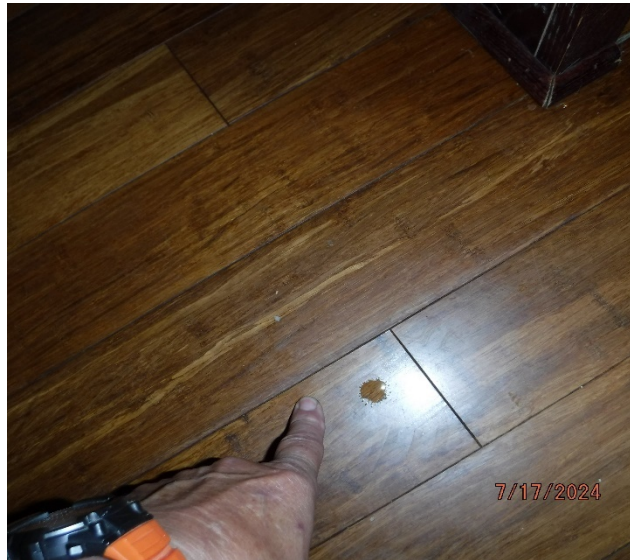
Figure 9

- There were lifting laminate flooring in the kitchen. Recommend an evaluation by a flooring company. **(Figure 9)**
- Note: There were one or more toilets with cracked or missing caulk at the base to floor connection points. Sewage can come out from under the toilet. Recommend sealing with silicone caulk.
- Note: There were cracks in the garage floor. This can cause fluid intrusion. Recommend sealing.

The inspector recommends that all the floor deficiencies listed above be evaluated and repaired by a General Contractor. The General Contractor may find additional defects besides those listed above.

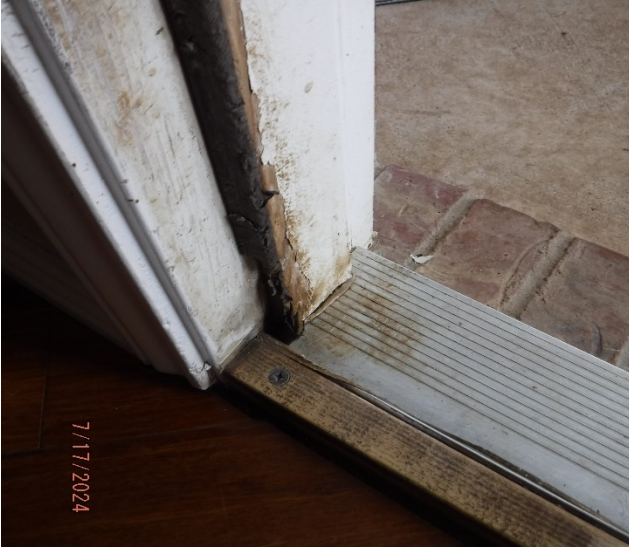
Figure 12

- There was torn or damaged weather stripping on the back patio door. This can cause water or insect intrusion. Recommend repair by a door company. **(Figure 12)**
- Note: There were missing door stops in areas around the home. This may cause wall damage. Recommend adding door stops.

The inspector recommends that due to all the internal, external, and garage door deficiencies be evaluated and repaired by a Door Specialist. The Door Specialist may find additional defects besides those listed above.

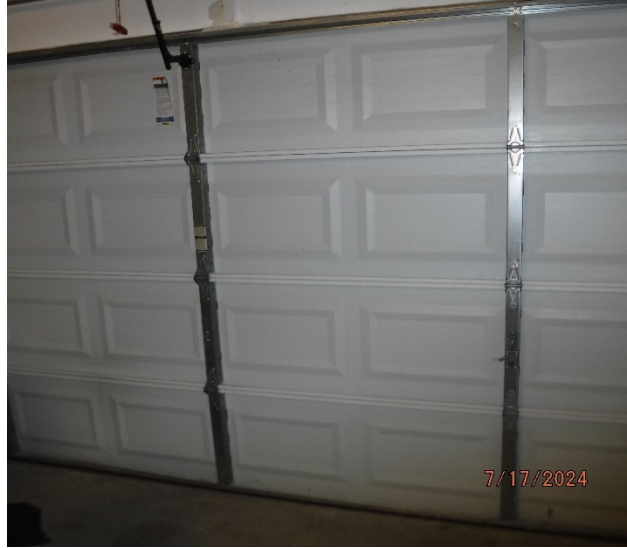
Figure 13

- The door did not stay in a fixed position when operated manually. This can cause personal injury. **(Figure 13)**
- Note: The garage door was noisy during operation. This can cause binding of the door. Recommend lubricating garage door.

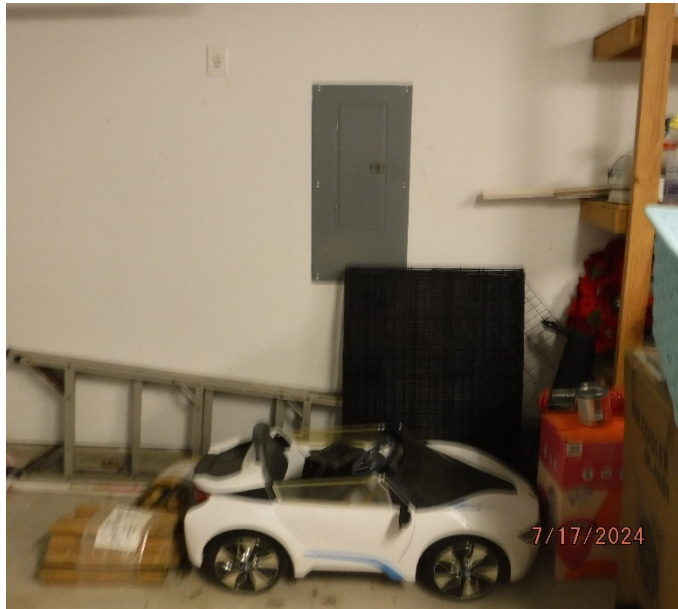
Figure 14

- There was not the required working space at points around the panel. There must be 30-inch minimum space on the sides and 36-inches open space in the front of the panel. Recommend repair. **(Figure 14)**
- Note: There were some, but not all the required dedicated circuits in the panel that are required by current standards. Recommend an evaluation by a licensed electrical contractor.
- Note: There was not an external intersystem bonding block located by the meter. Current standards require an external intersystem bonding termination block. Recommend an evaluation by a licensed electrical contractor.

The inspector recommends that all the service entrance and panel deficiencies listed above be evaluated and repaired by a licensed Electrical Contractor. The licensed Electrical Contractor may find additional defects besides those listed above.

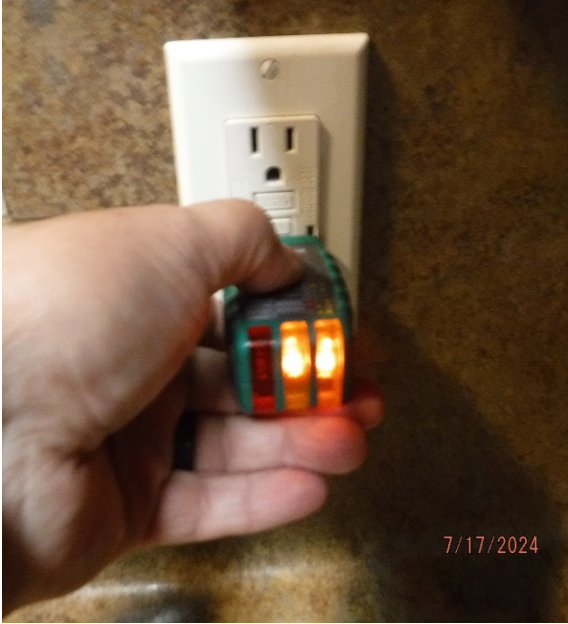
Figure 15

- The kitchen water side GFCI receptacles did not open when tested. This is a safety issue. Recommend replacement of the GFCI receptacle by a licensed electrical contractor. **(Figure 15)**

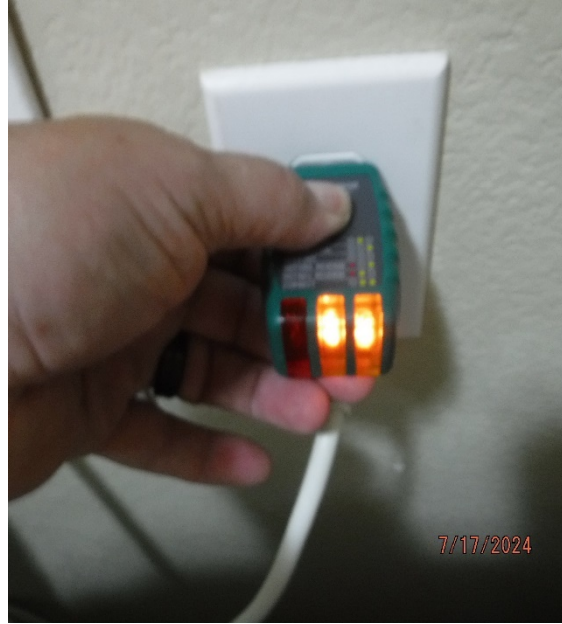
Figure 16

- The laundry room did not have GFCI receptacle(s) on all receptacles in the laundry aera. This is a safety issue. This is a new requirement and was not a requirement when the house was built. Recommend adding GFCI receptacle(s) by a licensed electrical contractor. **(Figure 16)**

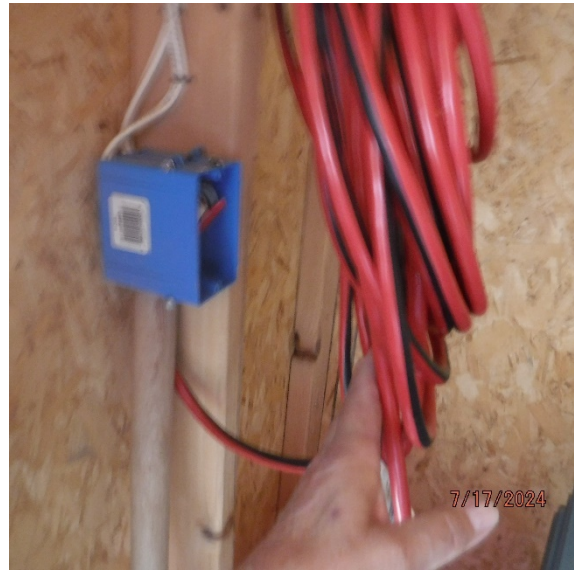
Figure 18

- There is an improper use of an extension cord to power the shed. Recommend a licensed electrical contractor and additional receptacles by a licensed electrical contractor. **(Figure 18)**

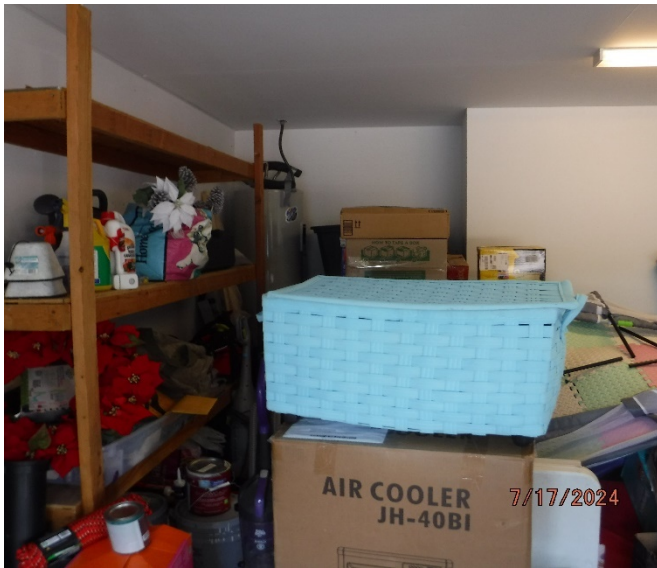
There were areas that were inaccessible.
