**Chubby Hubby
Home Inspection, P L L C**

Inspectors: Dale Sherman TREC 21563 & Maryann Sherman TREC 24716

PROPERTY INSPECTION REPORT FORM

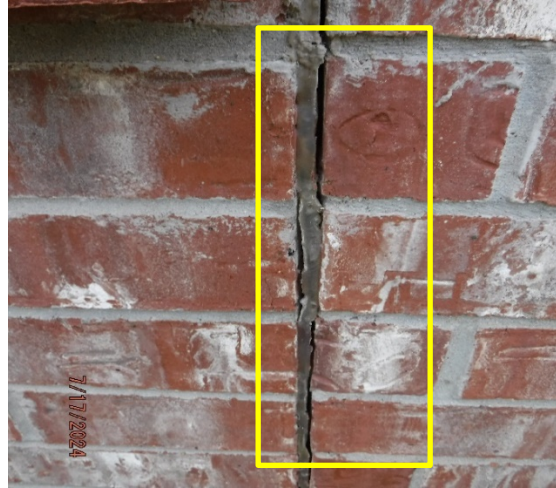
Figure 7

- There were areas of wall brick-and-mortar joint separation above the front entry door. Recommend an evaluation and repair by a mason. **(Figure 6)**
- There were expansion joints that have cracked and/or missing caulk, recommend adding elastomeric caulk to prevent water intrusion and termite infestation. **(Figure 7)**
- There are missing weepholes over the garage door. Recommend adding weepholes for drainage. **(Figure 8)**
- Note: There were exterior faucets that should be sealed at the wall connection points to prevent water intrusion.
- Note: There were exterior lights that should be sealed at the wall connection points to prevent water intrusion with elastomeric caulk.

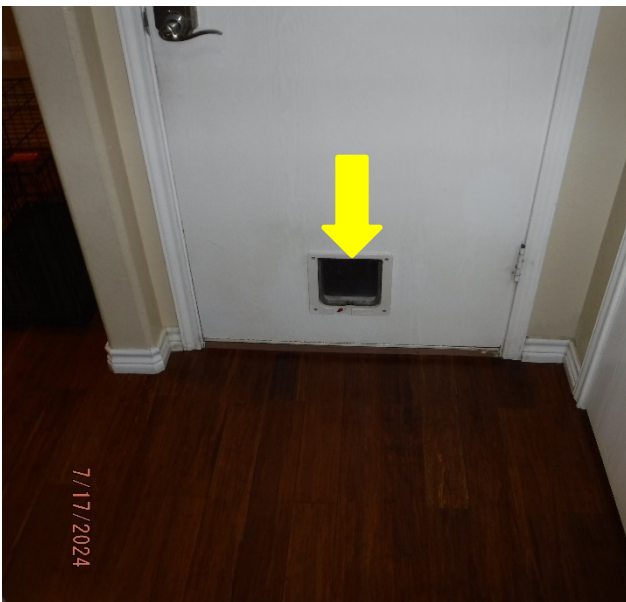
Figure 10

- There is not a solid wood door between the residence and the attached garage. The home must contain a solid wood door not less than 1-3/8 inches in thickness, a solid or honeycomb core steel door not less than 1-3/8 inches thick, or a 20-minute fire-rated door between the residence and an attached garage. Recommend replacement by a door company. **(Figure 10)**
- There was not a self-closing hinges or automatic closing devices on the attached garage door walk through door to the home. This is a new requirement and was not a requirement when the house was built. Recommend adding a closings-closing device or self-closing hinges by a door company if desired. **(Figure 11)**
- Note: There were missing door stops in areas around the home. This may cause wall damage. Recommend adding door stops.

The inspector recommends that due to all the internal, external, and garage door deficiencies be evaluated and repaired by a Door Specialist. The Door Specialist may find additional defects besides those listed above.

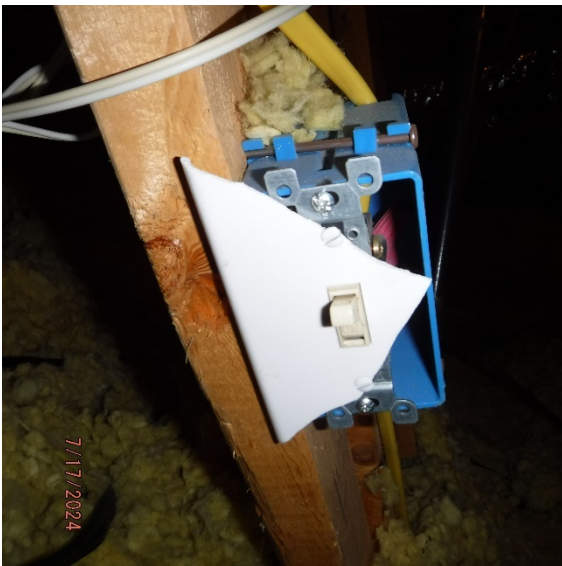
Figure 17

- There was a cracked switches cover for the attic light switch. Recommend replacement. **(Figure 17)**
- There were an insufficient number of Carbon monoxide detectors/alarms within the home at the time of the inspection. This is a safety issue. Carbon monoxide detectors/alarms were missing in the adjacent hallway to sleeping aeras. Recommend adding Carbon monoxide detectors/alarms.

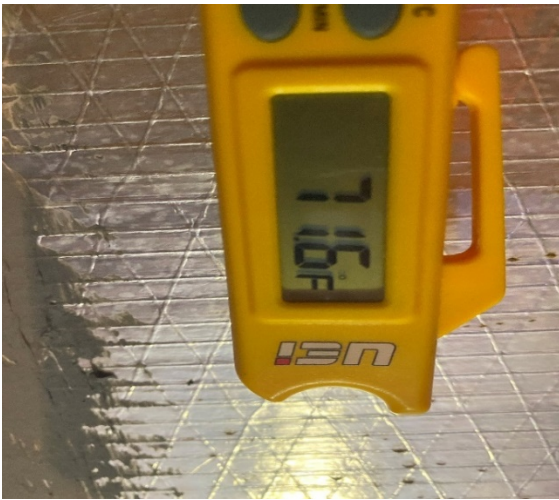
Figure 19 A

- The cooling system did not reach the standard differential temperatures of 15 to 22 degrees between the return and the closest output register. Recommend a licensed HVAC contractor evaluate the system and repair as needed. **(Figure 19 A & 19 B)**
- Note: The primary condensation line was not insulated to prevent condensation drips under the line. Recommend insulating the condensation line.

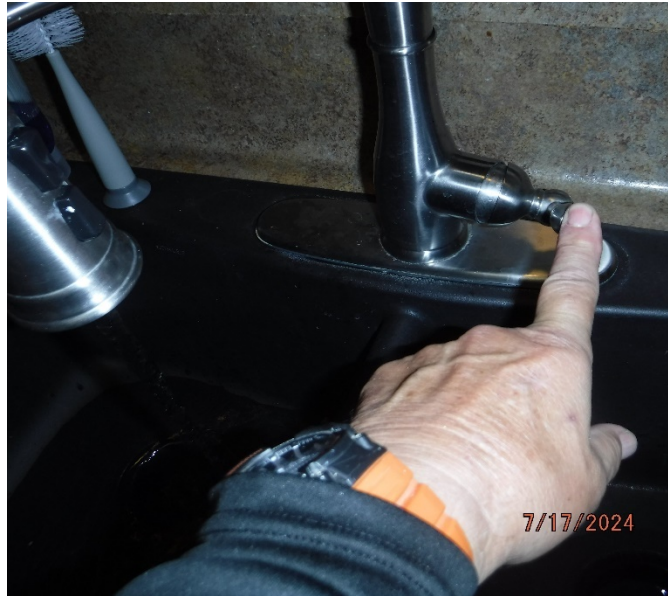
Figure 20

- The single kitchen sink faucet handle did not have temperature indicators for the hot and cold water. Without indicators the hot water should be applied when the handle is placed in the up position. The hot is applied when the handle is in the down position. This is a safety issue. Recommend repair by a licensed plumbing contractor. **(Figure 20)**
- There were missing anti-siphon valves on one or more external faucets at the time of the inspection. For safety reasons, an anti-siphon valve should be added to the exterior faucets to prevent cross contamination of the water supply.

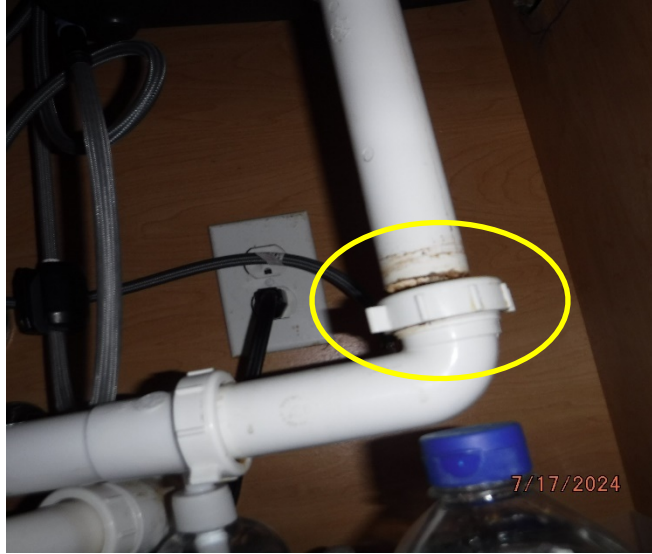
Figure 21

- The right-side kitchen sink drain was not securely attached to the tail piece. This can cause leakage and damage to the cabinet. Recommend repair by a licensed plumbing contractor. (Figure 21)

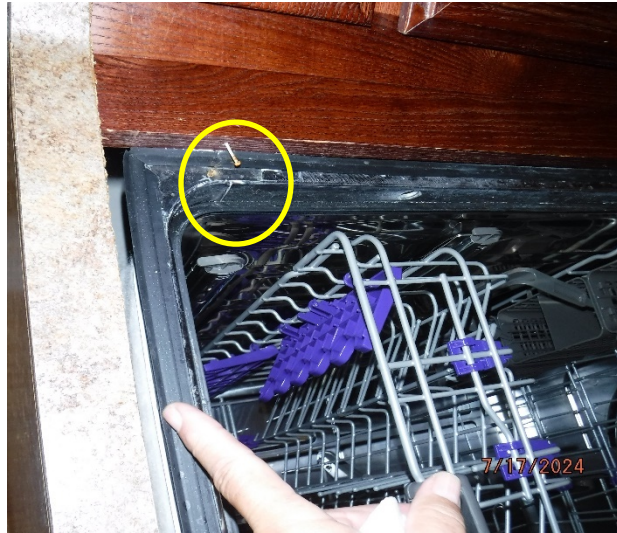
Figure 22

- The unit was loose or not secured to the countertop or cabinet. There are trim nails in areas trying to secure the dishwasher. Recommend securing the unit by an appliance specialist. **(Figure 22)**
- Note: The dishwasher had an odor after the cycle was complete. Recommend cleaning

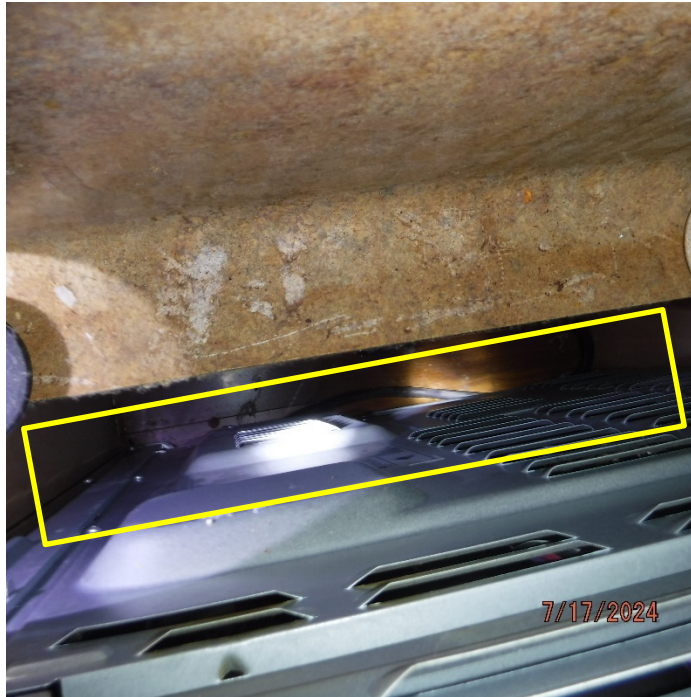
Figure 23

- There was not an anti-tipping device on the range. This is a safety issue. Recommend adding an anti-tipping device. **(Figure 23)**

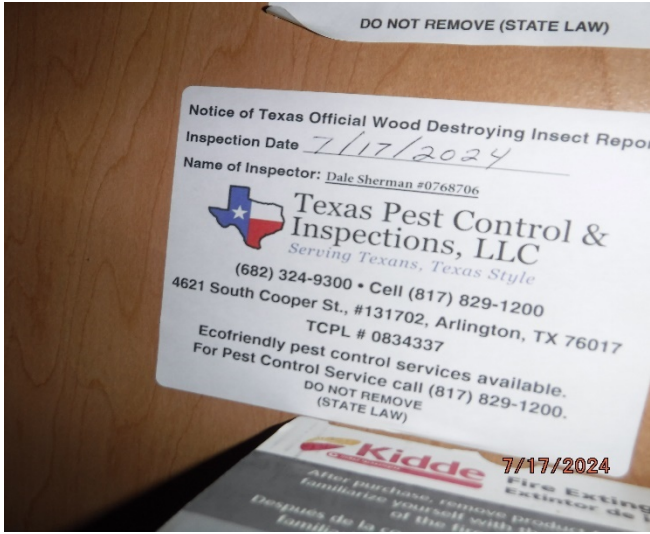
The WDI sticker was placed under the sink.
